INDOOR AIR QUALITY ASSESSMENT

**Stacy Middle School
66 School Street
Milford, MA 01757**

Prepared by:
Massachusetts Department of Public Health
Bureau of Environmental Health
Indoor Air Quality Program
September 2007

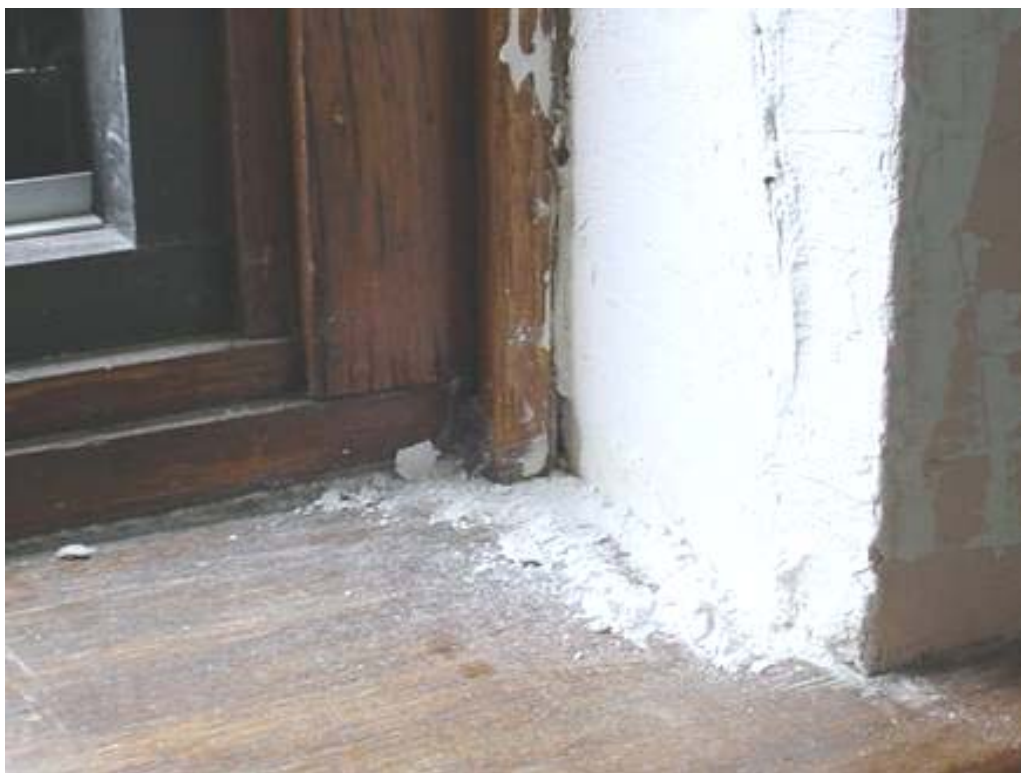
Picture 1

Although indoor PM_{2.5} concentrations were below the NAAQS, settled dust and efflorescence (e.g., mineral deposits), was observed on flat surfaces in many areas (Table 1/Pictures 1-4). Dust can be irritating to eyes, nose and respiratory tract. Efflorescence is a characteristic sign of water damage to building materials, but it is not mold growth. As moisture

Plaster Dust on Classroom Window Sill

1. Scrape/remove loose/hanging plaster and paint on ceiling and around window sills.
2. Clean flat surfaces using a high efficiency particulate arrestance (HEPA) filter equipped vacuum cleaner in conjunction with wet wiping.

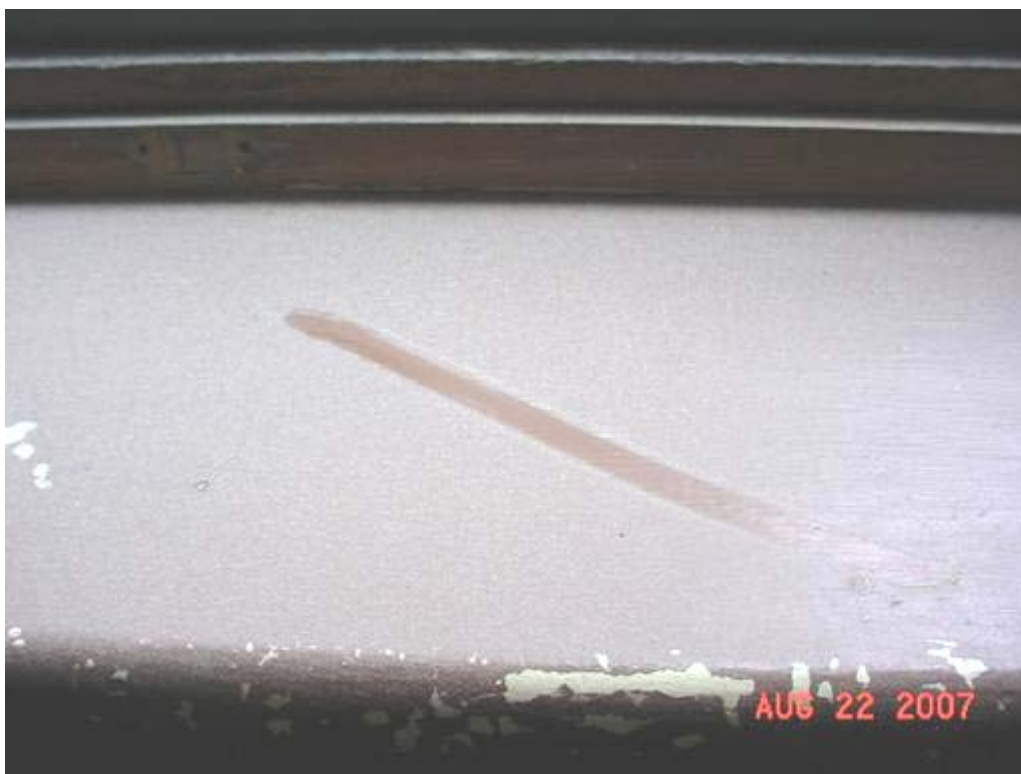
Picture 2

Settled Dust on Classroom Window Sill

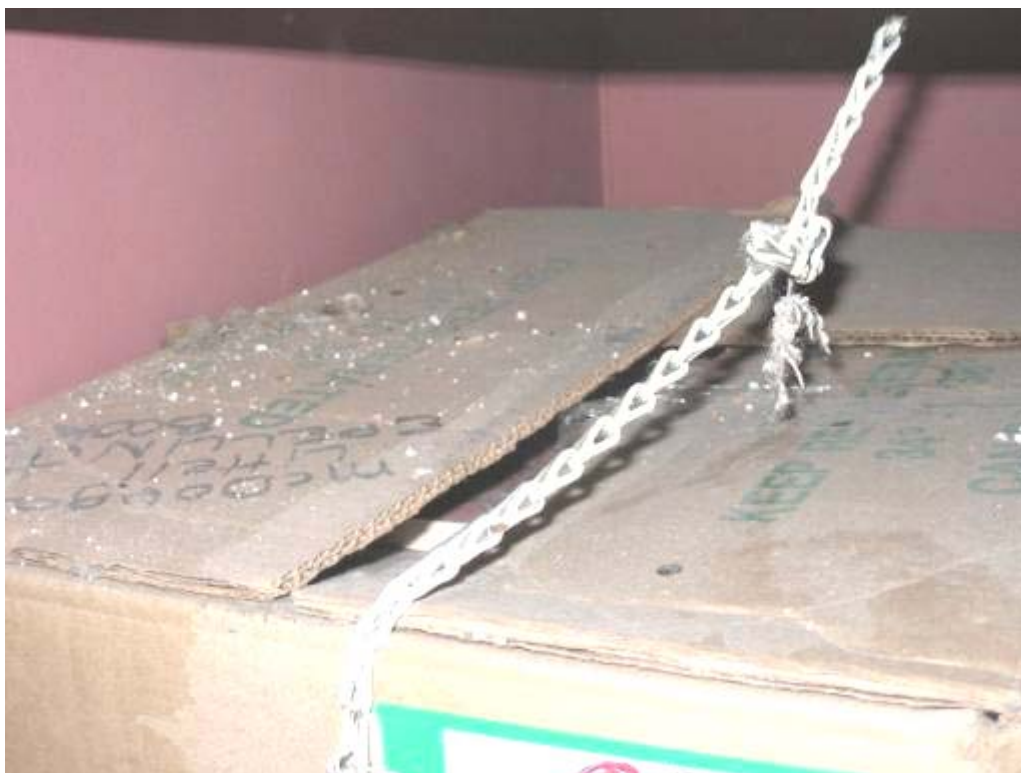
Picture 3

Settled Dust/Debris on Box in Classroom Exhaust Cubby

3. Clean and vacuum univent air diffusers and the interior of univent air handling cabinets.
4. Clean supply air diffusers, exhaust grates and cubbies (Picture 3).

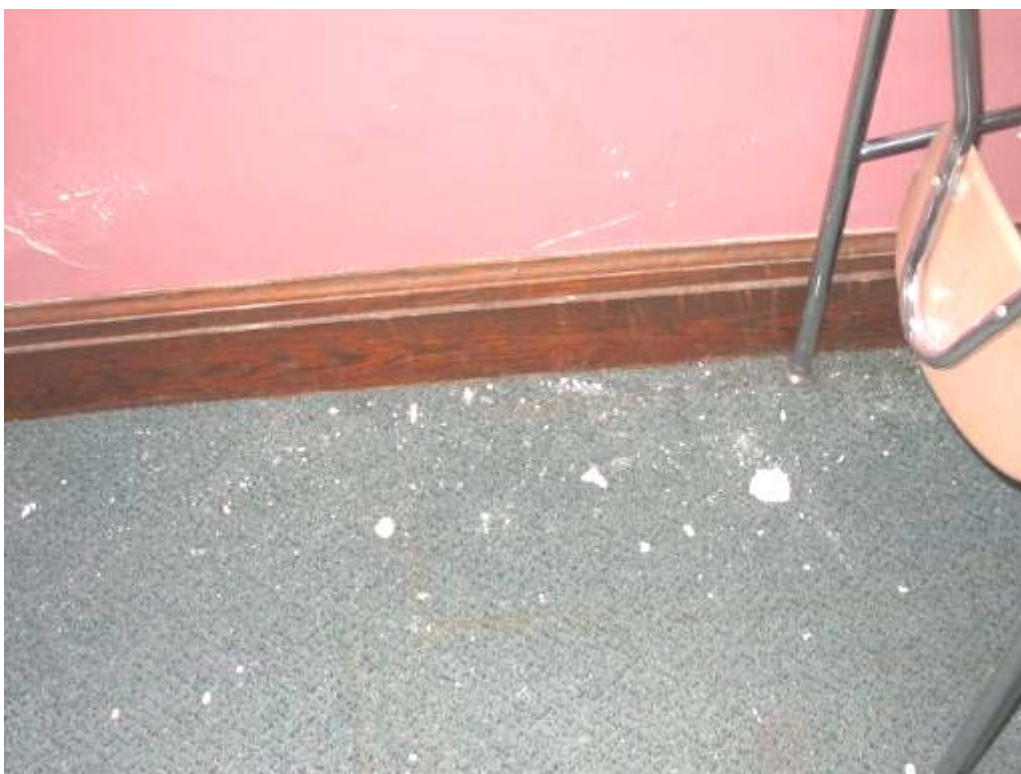
Picture 4

Dust/Debris on Classroom Carpet

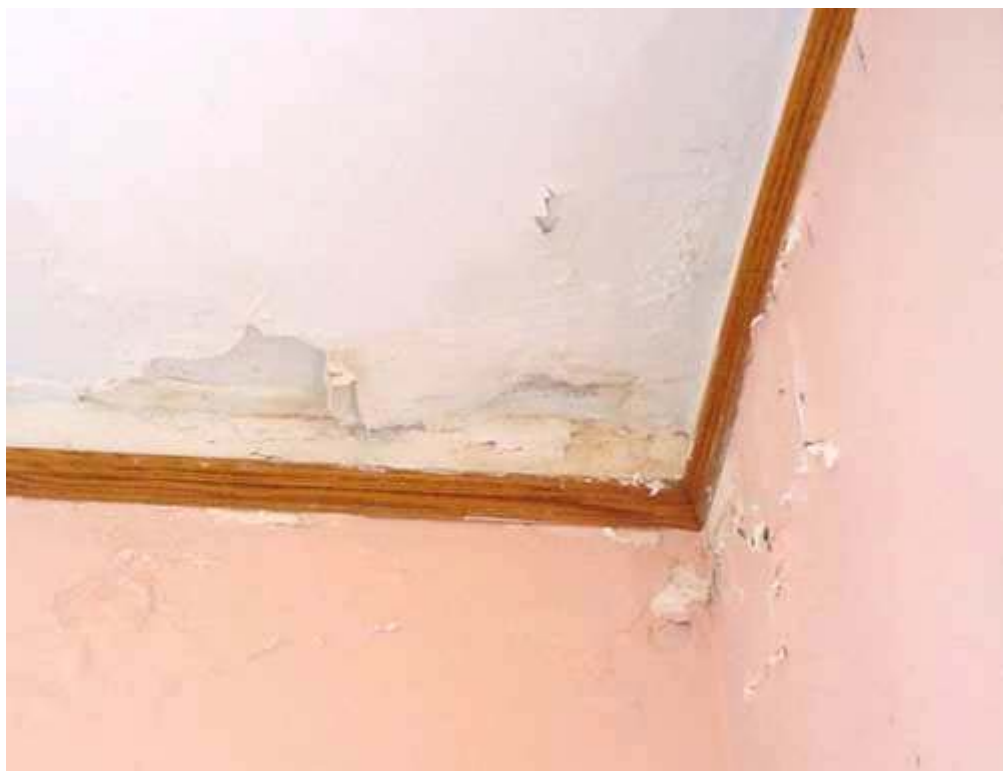
Picture 5

Water Damaged Ceiling and Wall Plaster

5. Continue with plans to finalize roof and repointing. Once completed, repair/replace any remaining water-damaged building materials (e.g., wall/ceiling plaster).

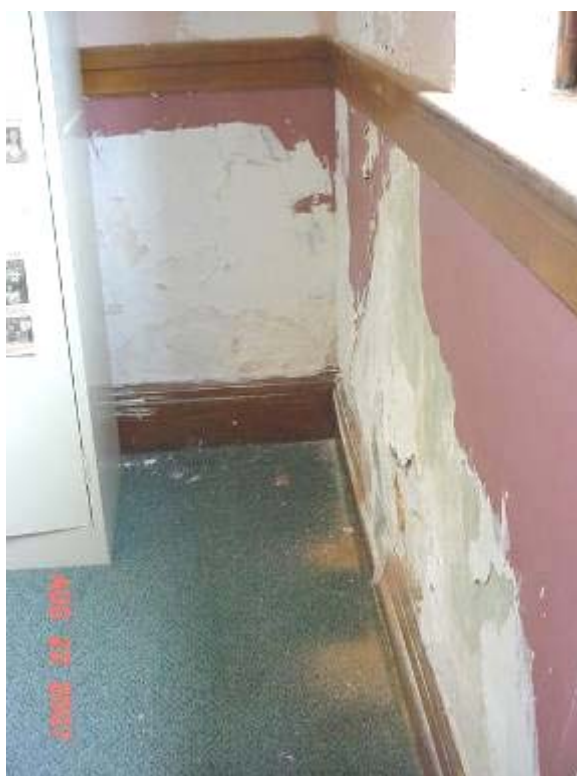
Picture 6

Severely Water Damaged Wall Plaster in Classroom 314

| Location | PM2.5* (µg/m ³) | Comments |
|---|---|--|
| 314 | 4 | Dirt, dust, debris-univent, floor & exhaust, window open, severe water damaged wall plaster in corner |

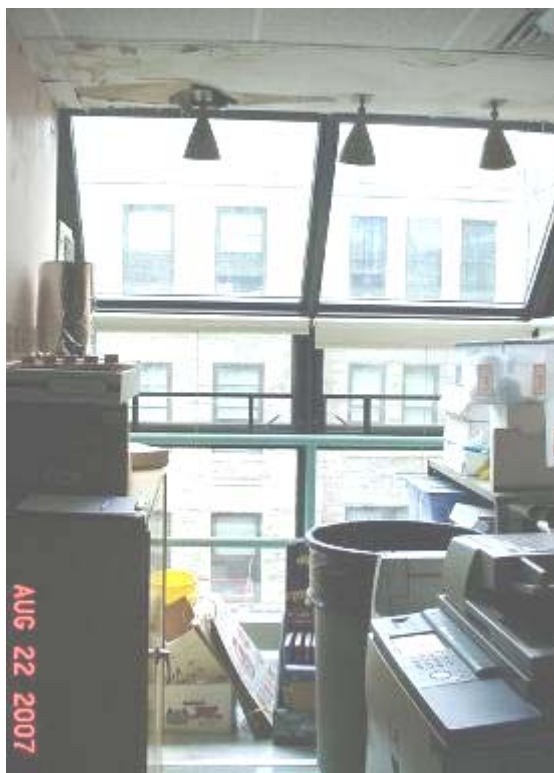
Picture 7

Water Damaged Ceiling and Walls around Protruding Window System in Science Storeroom

| Location | PM2.5* (µg/m ³) | Comments |
|---|---|--|
| Prep Room | | Water damaged ceiling/walls around protruding window |

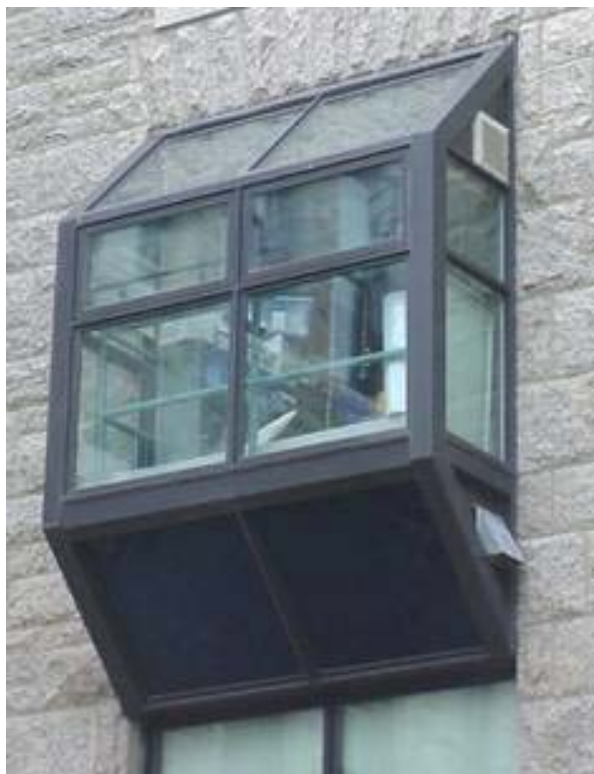
Picture 8

Exterior View of Protruding Window System of Science Storeroom

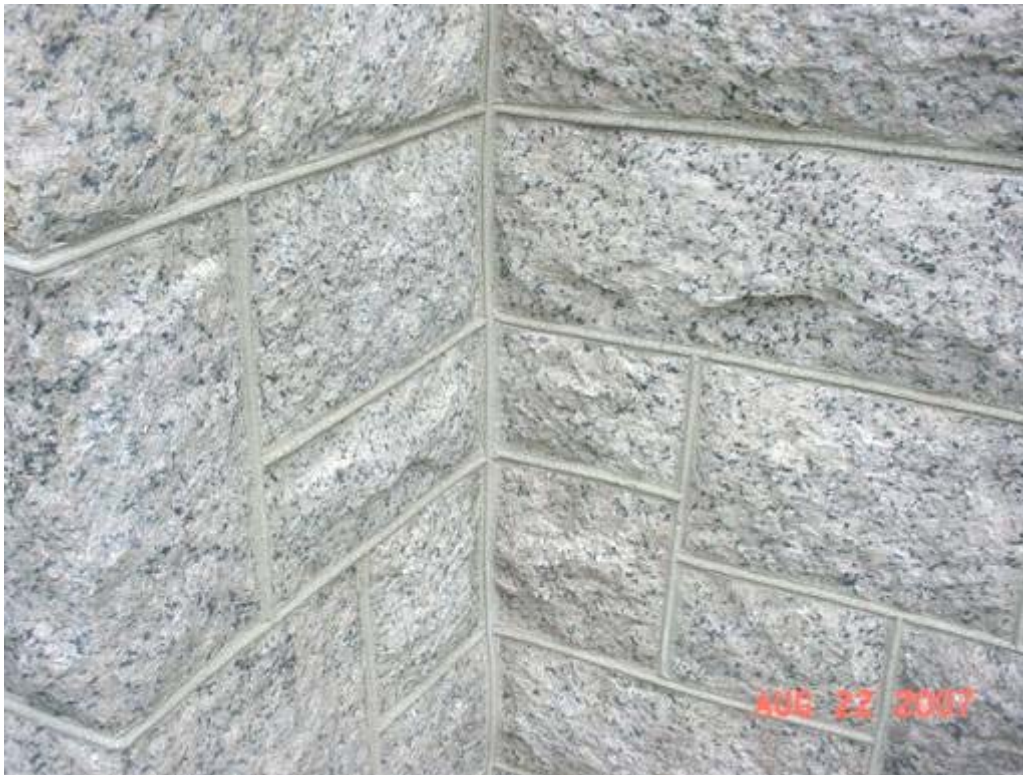
Picture 9

penetrates and works its way through building materials (e.g., plaster), water-soluble compounds dissolve, creating a solution. As this solution moves to the surface, the water evaporates, leaving behind white, powdery mineral deposits. Chronic water penetration through the building envelope that has damaged building materials throughout the building (Pictures 5 through 8), should be alleviated by both the repointing of the exterior of the building (Picture 9) and roof replacement.

Repointed Exterior Granite Blocks

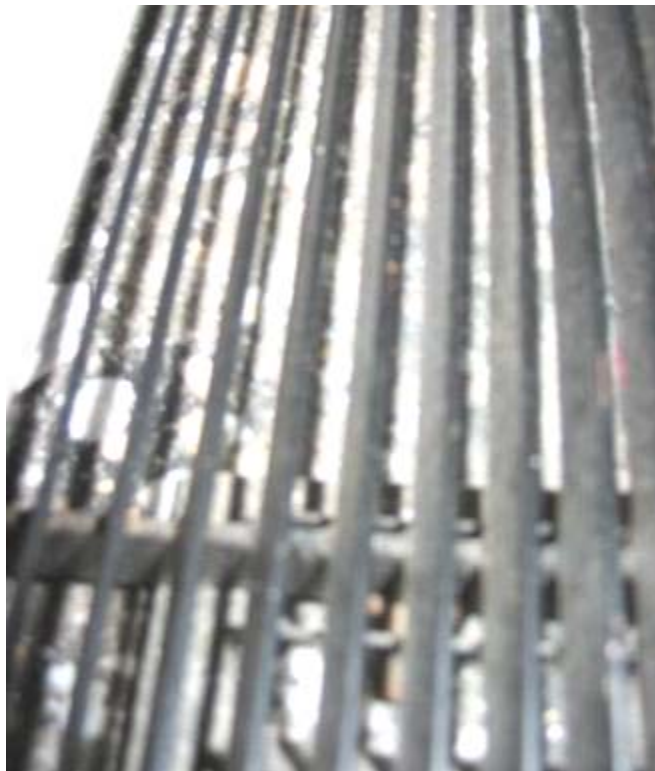
Picture 10

Settled dust and debris was also observed within univent cabinets (Pictures 10 and 11) and on supply diffusers (Picture 12) and exhaust vents (Picture 13). Dust and particulate matter accumulated on diffusers or within a univent can be aerosolized when these units are activated. In addition, odors and fumes can be generated from heating of materials on or in close proximity to univent heating elements. Supply diffusers can accumulate dust. In contrast, exhaust vents typically accumulate dust and debris because the draw of air through the vents is also *removing* airborne materials from the building. If rooftop exhaust motors are deactivated, backdrafting can occur, and materials accumulated on the exhaust vent can be reaerosolized into occupied areas.

Dirt, Dust and Debris in Univent Air Diffuser

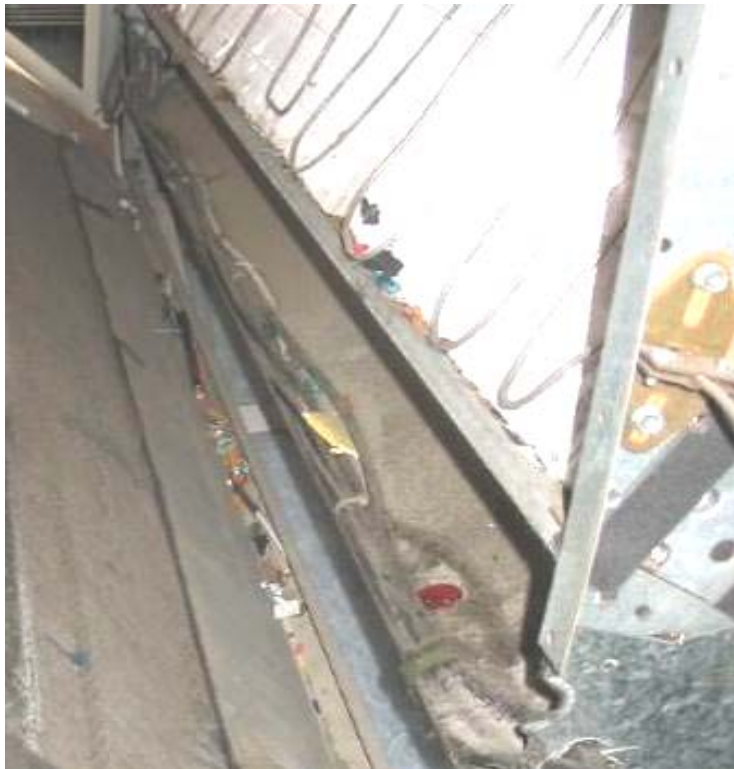
Picture 11

Dirt, Dust and Debris in Univent Air Handling Cabinet

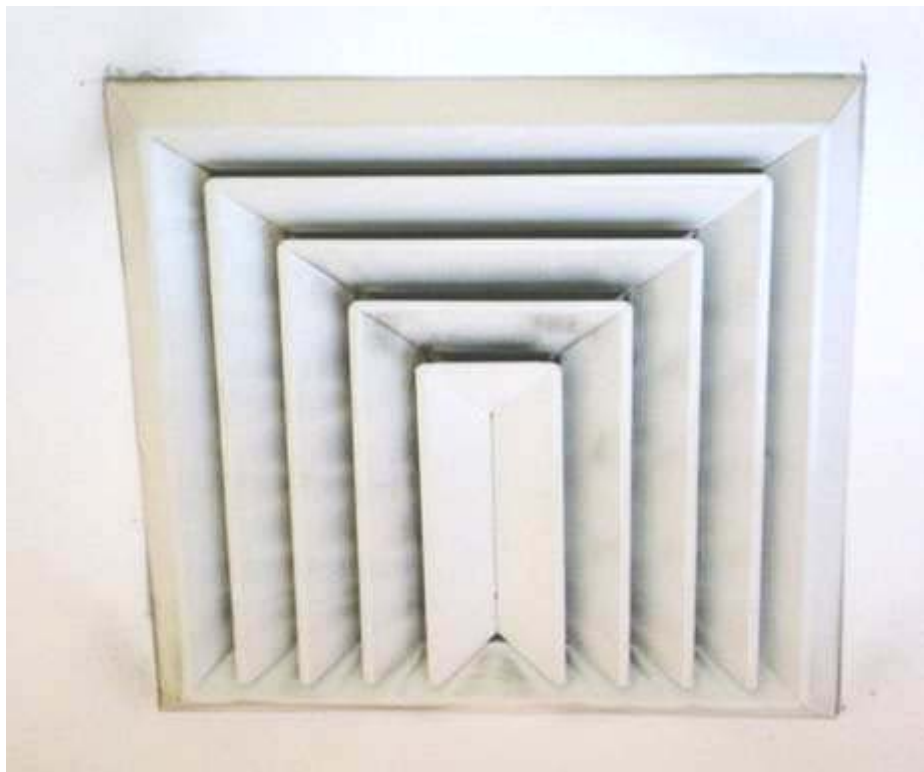
Picture 12

Dust/Debris Accumulation on/around Supply Diffuser

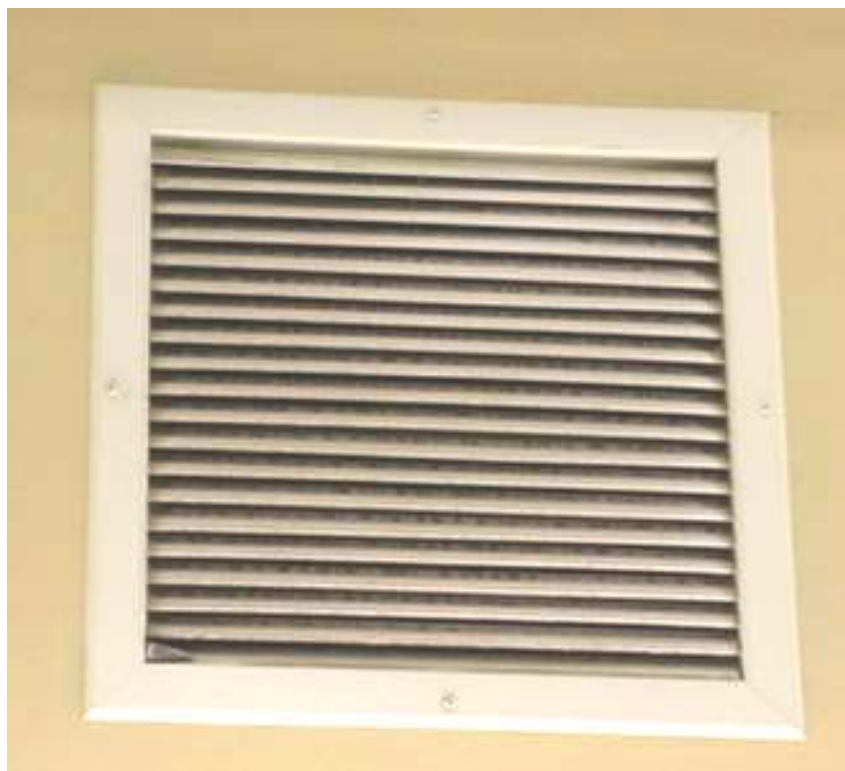
Picture 13

Dust/Debris Accumulation on/in Exhaust Vent

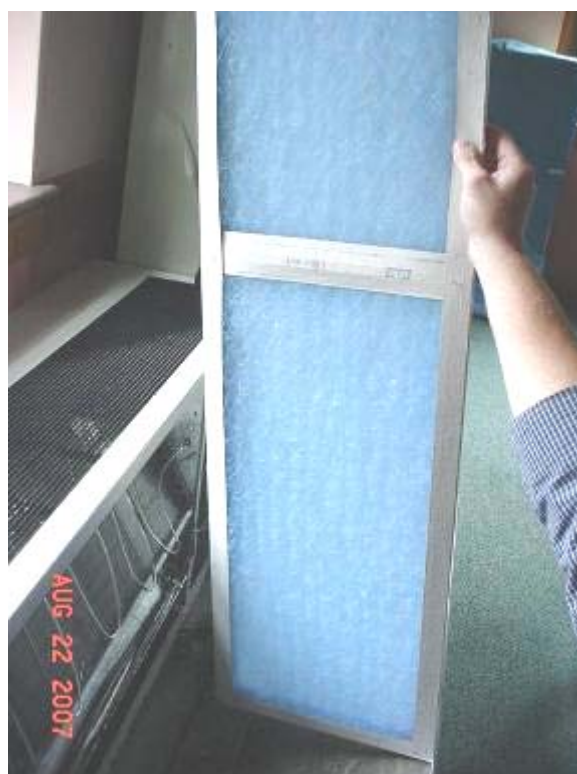
Picture 14

BEH staff examined several filters installed in rooftop air handling units and univents. All filters observed were found to be clean and appeared to have been recently changed. However, filters at the SMS are of a fibrous mesh type that provides minimal filtration (Pictures 14 and 15). In order to decrease aerosolized particulates, disposable filters with an increased dust spot efficiency can be installed. The dust spot efficiency is the ability of a filter to remove particulates of a certain diameter from air passing through the filter. Filters that have been determined by ASHRAE to meet its standard for a dust spot efficiency of a minimum of 40 percent (Minimum Efficiency Reporting Value equal to 9) would be sufficient to reduce many airborne particulates (Thornburg, 2000; MEHRC, 1997; ASHRAE, 1992). Note that increasing filtration can reduce airflow (called pressure drop), which can subsequently reduce efficiency

Fibrous Mesh Type Filter for Univent

7. Consider increasing the dust-spot efficiency of HVAC filters. Prior to any increase of filtration, each piece of air handling equipment should be evaluated by a ventilation engineer as to whether it can maintain function with more efficient filters.

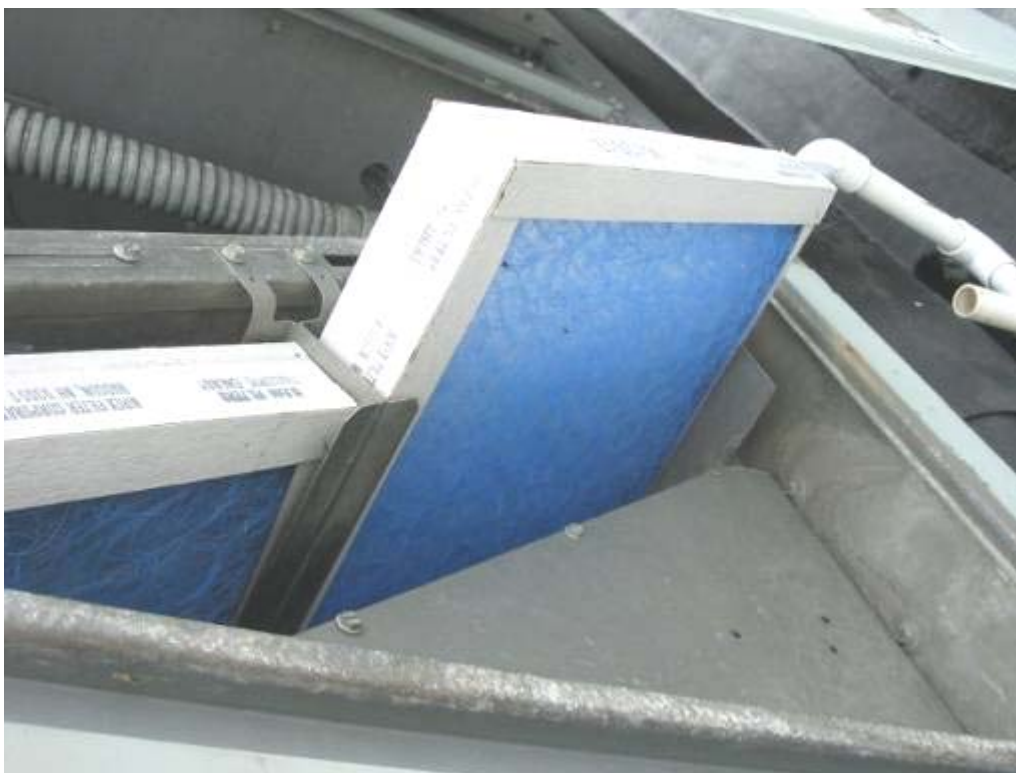
Picture 15

Fibrous Mesh Type Filter for Rooftop AHU

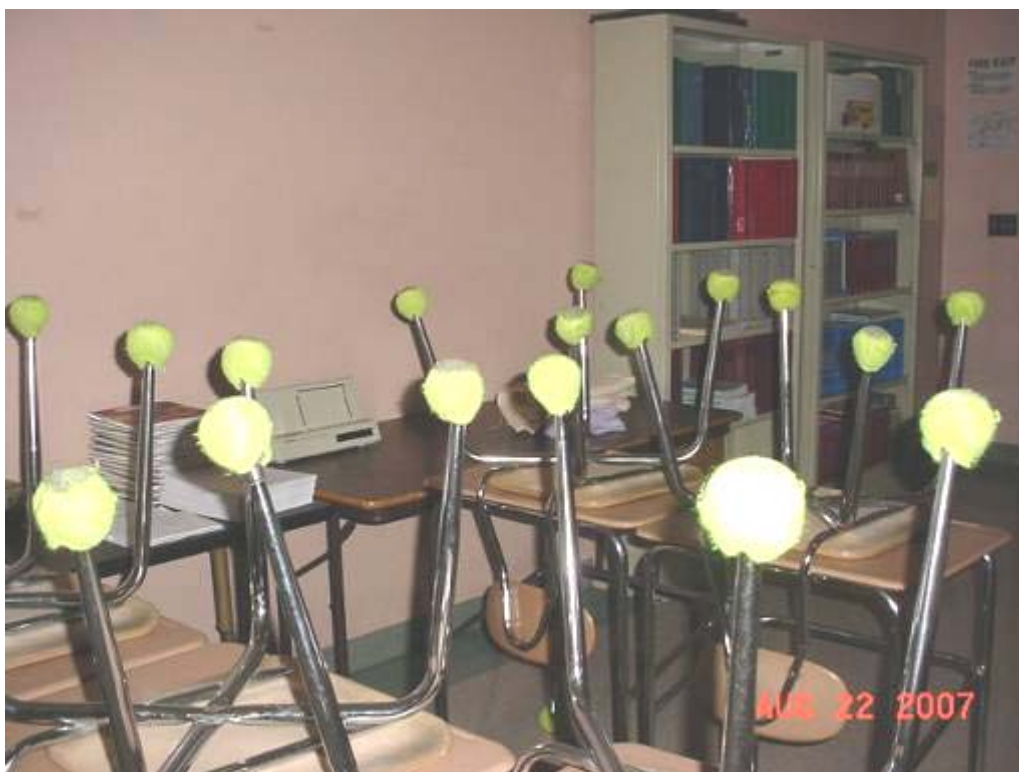
Picture 16

Finally, in an effort to reduce noise from sliding chairs, tennis balls had been spliced open and placed on chair legs in a several areas (Table 1/Picture 16). Tennis balls are made of a number of materials that are a source of respiratory irritants. Constant wearing of tennis balls can produce fibers and off gas VOCs. Tennis balls are made with a natural rubber latex bladder, which becomes abraded when used as a chair leg pad. Use of tennis balls in this manner may introduce latex dust into the school environment. Some individuals are highly allergic to latex (e.g., spina bifida patients) (SBAA, 2001). It is recommended that the use of materials containing latex be limited in buildings to reduce the likelihood of symptoms in sensitive individuals (NIOSH, 1997). A question and answer sheet concerning latex allergy is attached as Appendix B (NIOSH, 1998).

Tennis Balls on Chair Legs

6. Consider discontinuing the use of tennis balls on chair legs to prevent latex dust generation. Alternative “glides” can commonly be purchased from office supply stores; refer to Picture 17 for an example.

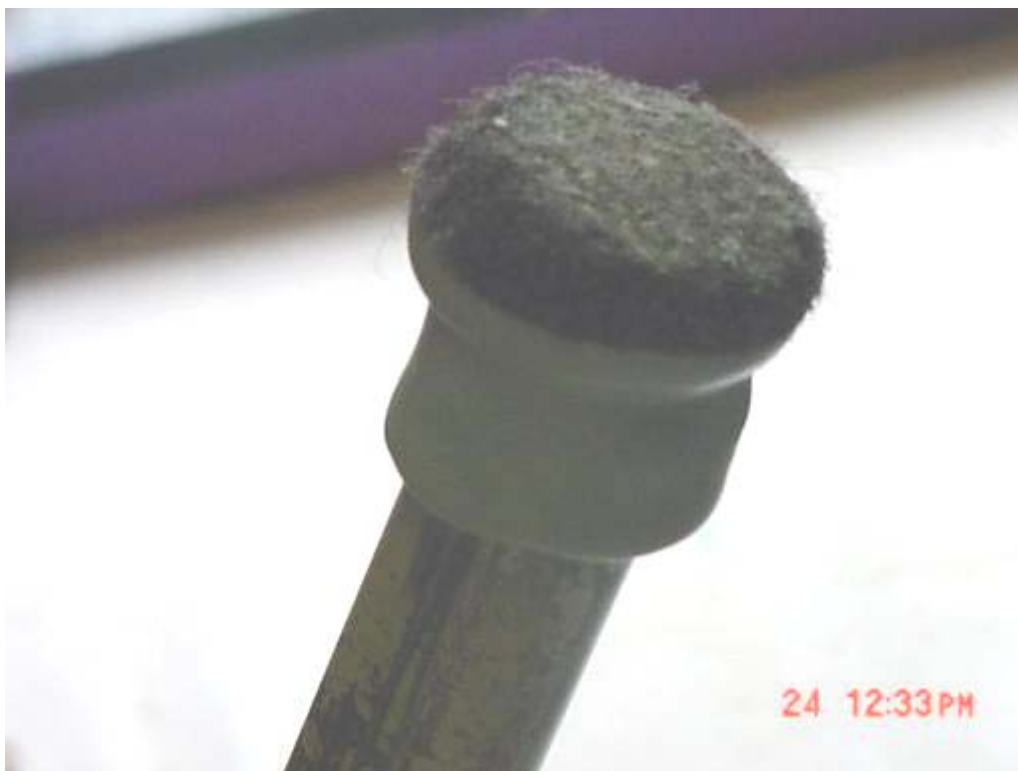
Picture 17

“Glides” for Chair Legs that can be used as an Alternative to Tennis Balls
